**SI 1001**  
For technical personnel only!  
1/3

# SERVICE INFORMATION

## SWIRL CHAMBER INSERTS

### THE CORRECT HANDLING OF OLDER CYLINDER HEADS

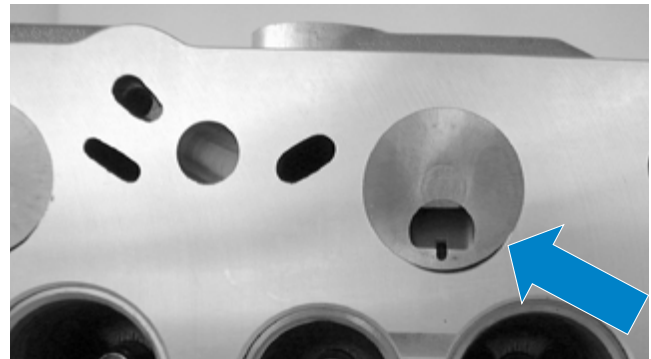
In swirl chamber engines, the steel swirl chamber inserts are inserted from the combustion side into the cylinder head (Fig. 1). The inserts are not pressed into the cylinder head. Rather, they fit exactly in the cylinder head. The inserts project by 0.02 – 0.07 mm beyond the face of the cylinder head (the exact projection dimension "X" depends on the manufacturer). This projection presses the chamber of the cylinder head gasket into its seat, so that it cannot move during operation.

Fig. 1: cylinder head with installed swirl chamber inserts

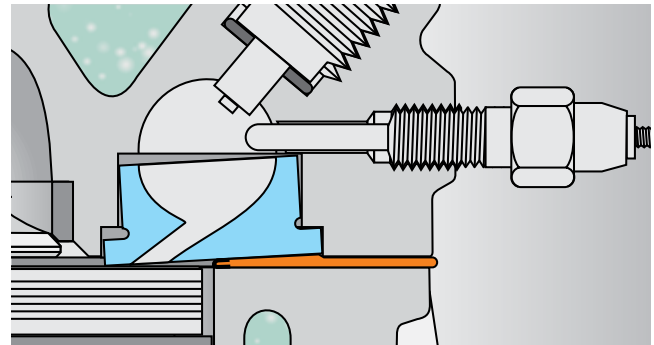
Fig. 3

1. The swirl chamber has set, or did not have the necessary projection on installation. The swirl chamber insert tilts in its seat and collides with the piston. This tilting is compounded by the combustion pressure and overheating of the chamber (poor heat dissipation, Fig. 3).

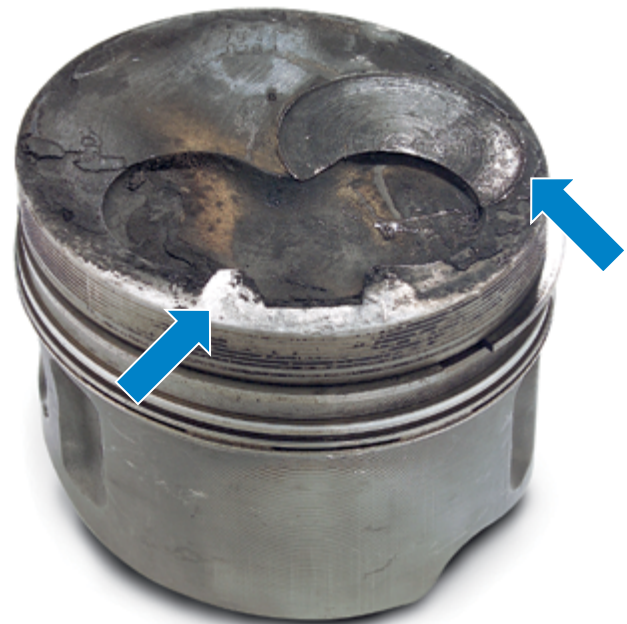
2. If the engine overheats, e.g. due to abnormal combustion, the components expand considerably. This cancels out the free movement of the piston, so that it knocks against the swirl chamber, the valves and the cylinder head.

Impact marks from the swirl chamber insert (arrow) and intake valve can be seen on the piston in Figure 4. The damage was caused by engine overheating.

Fig. 4: impact marks due to engine overheating
